## SAXON HARBOR HIGHWAY REPAIR

### Elliptical Concrete Pipe Reopens Highway After Storm Washes Away Corrugated Steel Pipe

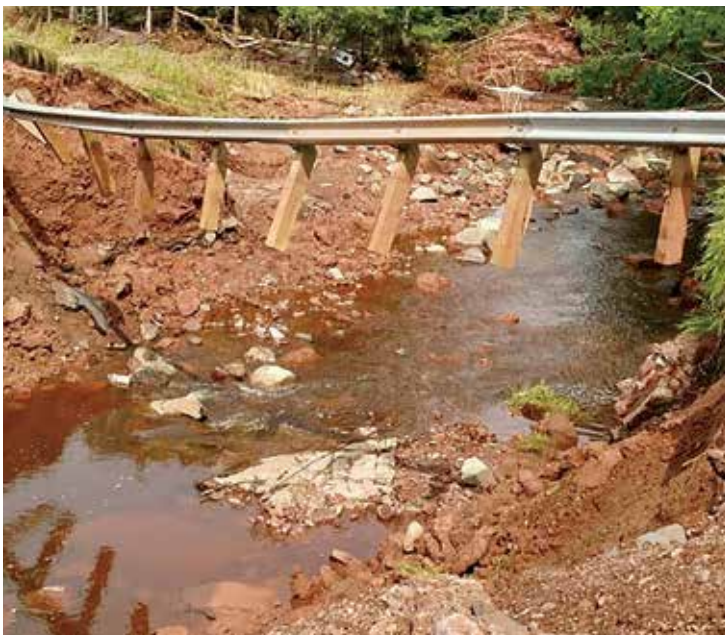
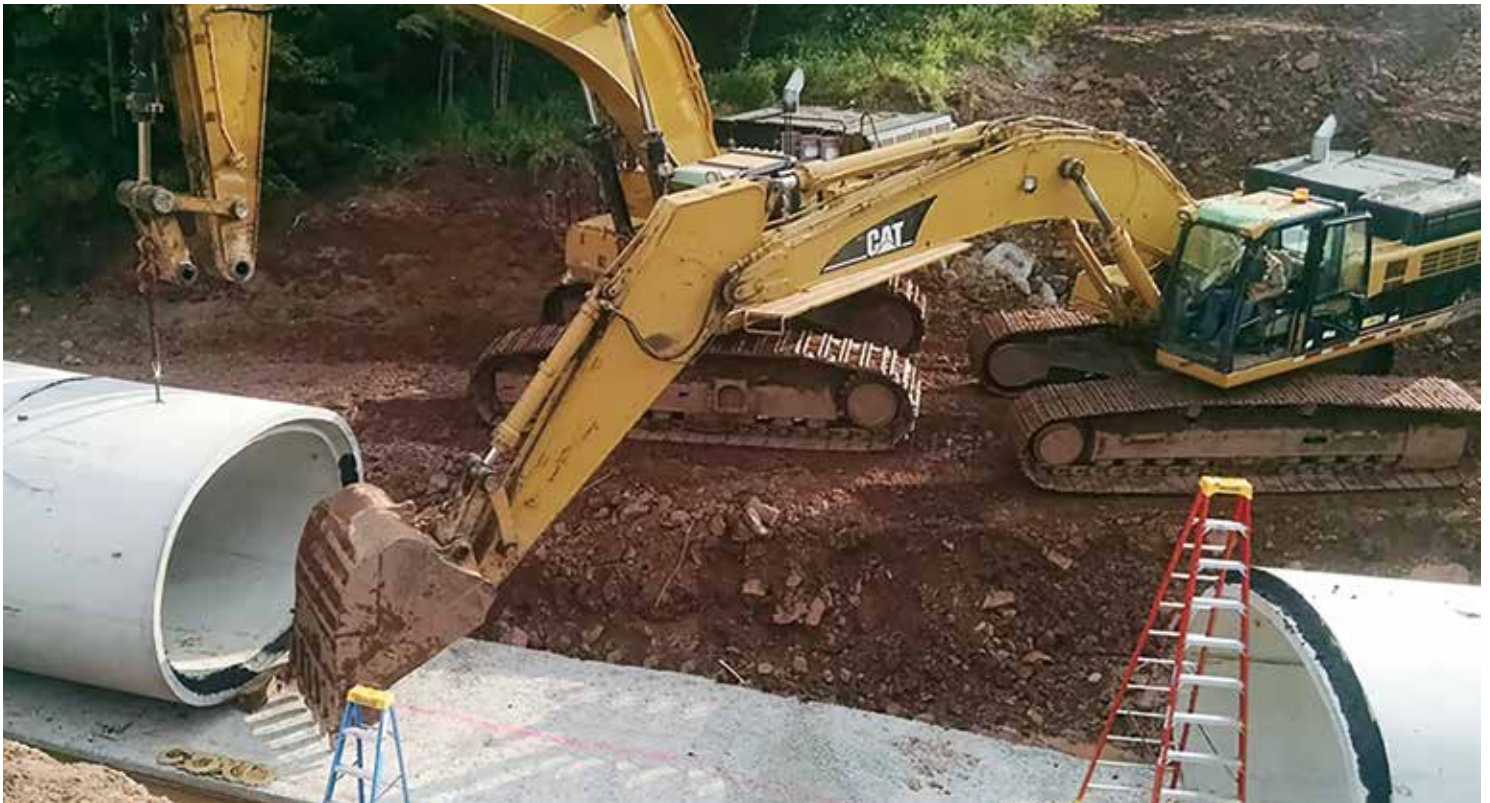
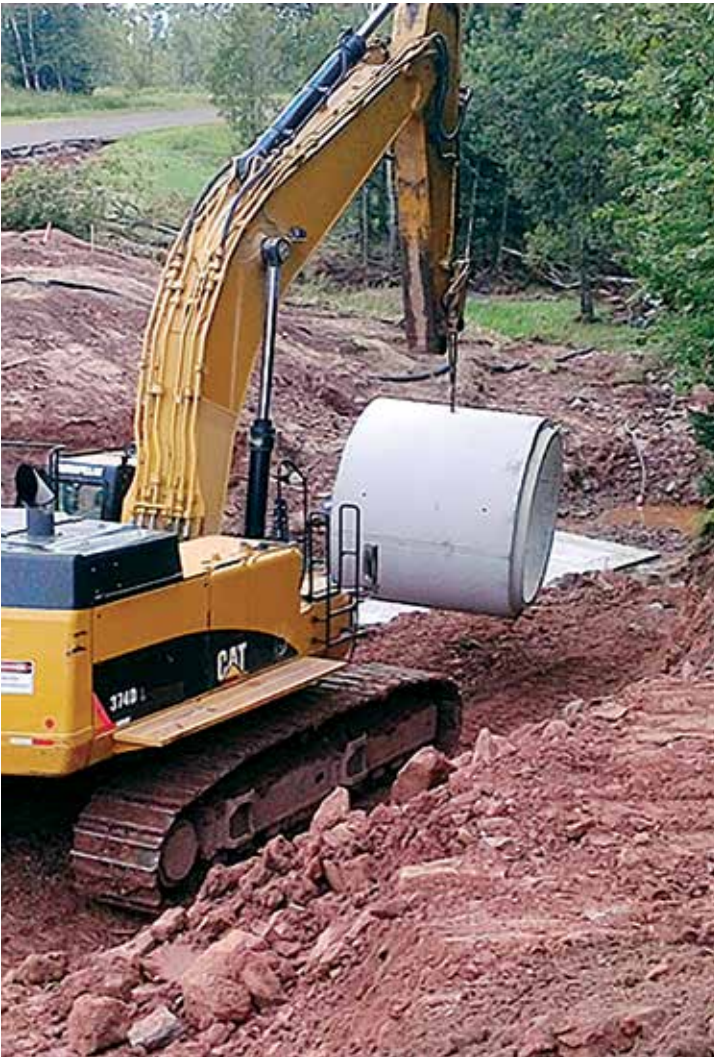
County Materials manufactured and delivered 128' of 87"x136" of reinforced concrete horizontal elliptical class IV pipe with a 100-year service life. Each pipe was 8' long 10" thick and weighed 34,800 lbs. This reinforced concrete culvert pipe was specified by WisDOT to replace the original steel pipe for its inherent strength and unique joint tie system. The joint tie system allows for placement of galvanized steel joint ties, which are placed across the concrete pipe joint of adjoining units to tie them together. This creates joints with added strength that promotes long-term performance of roadways.

The water surge wiped everything out, leaving only bedrock behind. The bedrock's surface was uneven, requiring preparation before the pipe could be placed. The contractor poured a concrete slab platform directly on top of the bedrock, giving the culvert pipe a steady platform for installation. After all 16 pieces were in place, and the joints sealed and tied together, the area was backfilled with soil, then paved over.
